BOEING
STRESS
CORROSION
TESTING
OF HIGH STRENGTH
STEELS

INVESTIGATION OF SUSCEPTIBILITY OF HIGH STRENGTH MARTENSITIC STEEL
ALLOYS TO STRESS CORROSION

TECHNICAL DOCUMENTARY REPORT NO. ASD-TDR-62-876
September 1962

(Prepared under Contract No. AF 33(616)-7839 by The Boeing Company,
Transport Division, Renton, Washington; Gary A. Dreyer, Author)

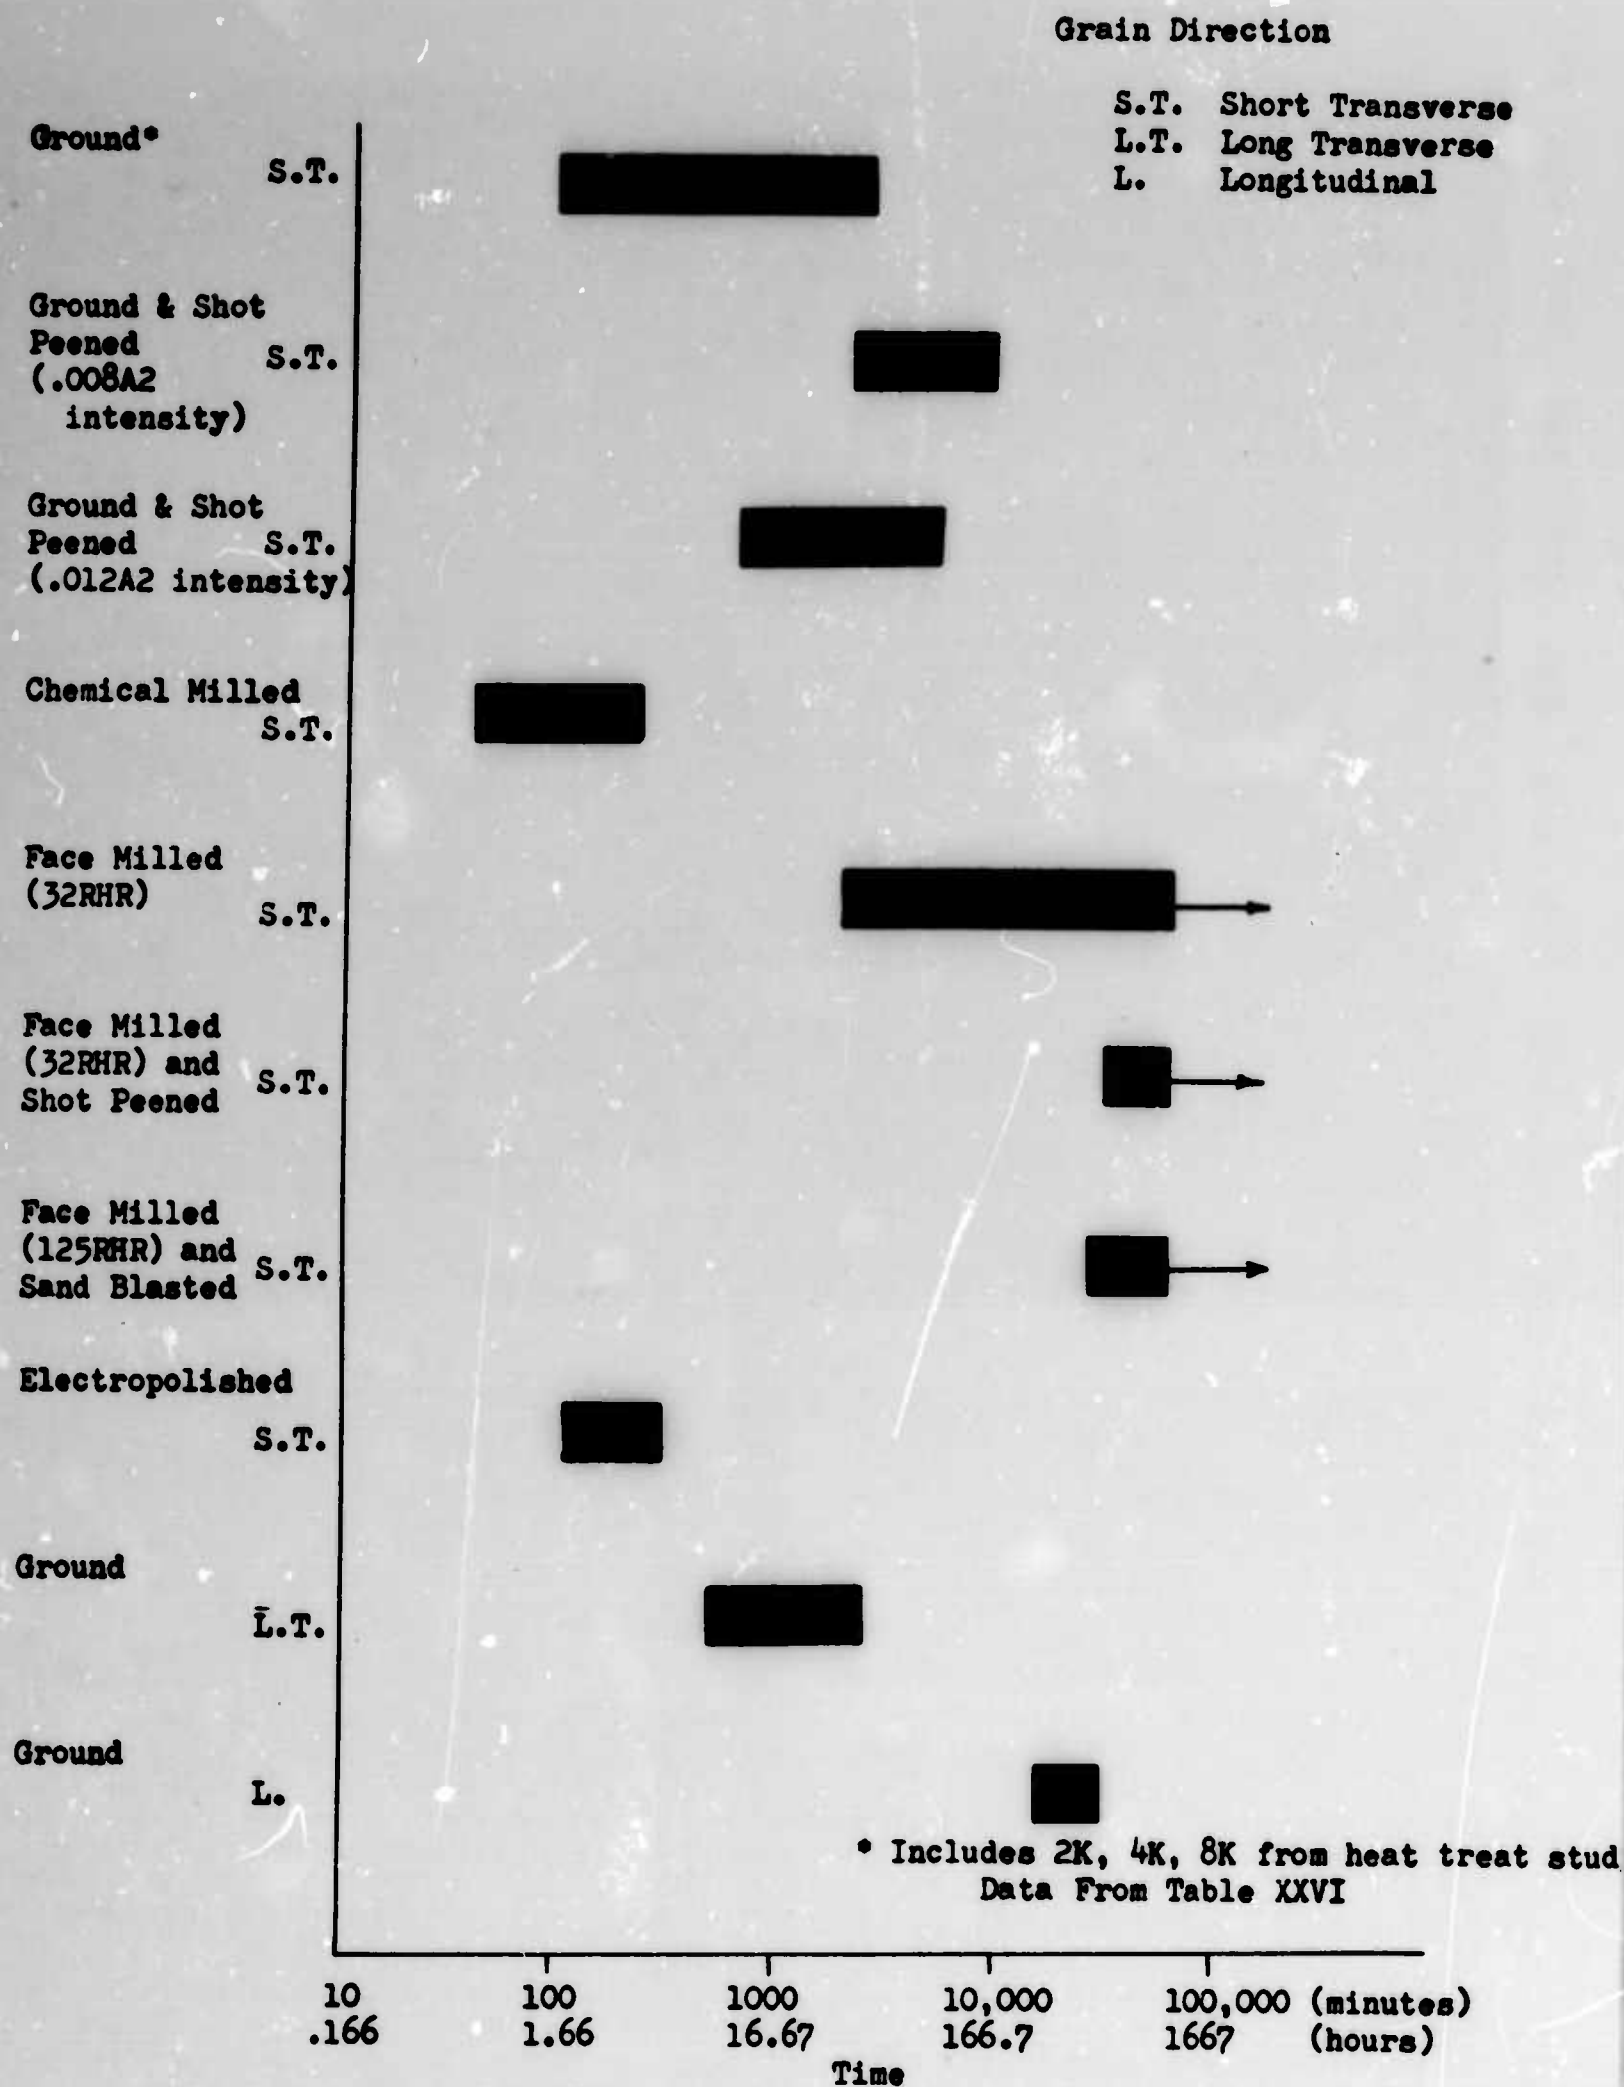
FIGURE 31. Range of Failure Times of 4340 U-Bend Specimens After Receiving Various Surface Finishes

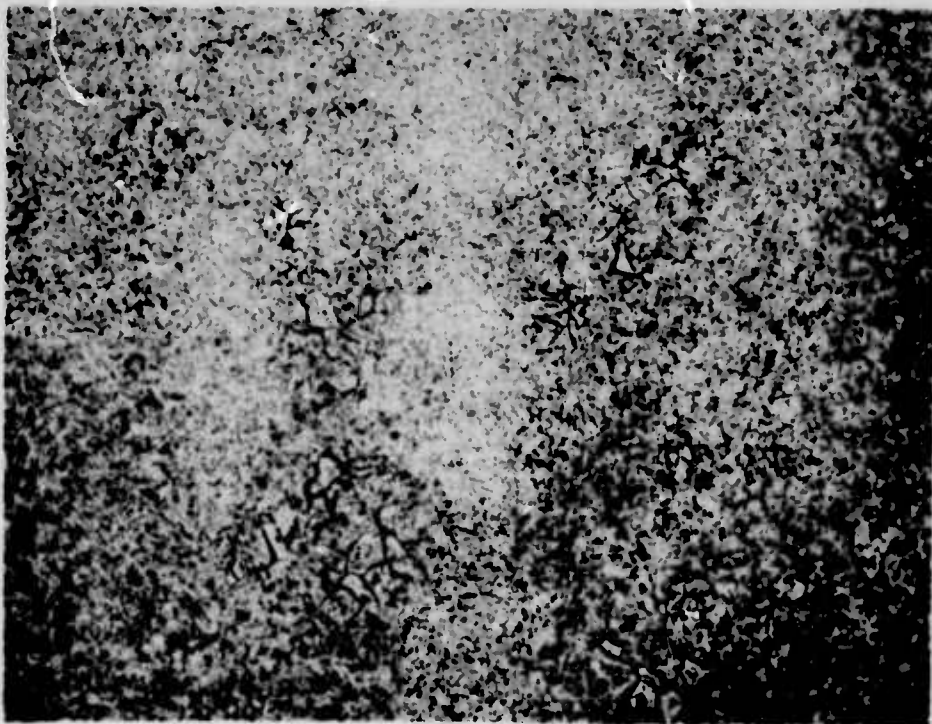
FIGURE 32
Banding in Specimen U B (Billet U, H-11) After 1100°F Temper
Nital plus Zephrian Chloride 50X

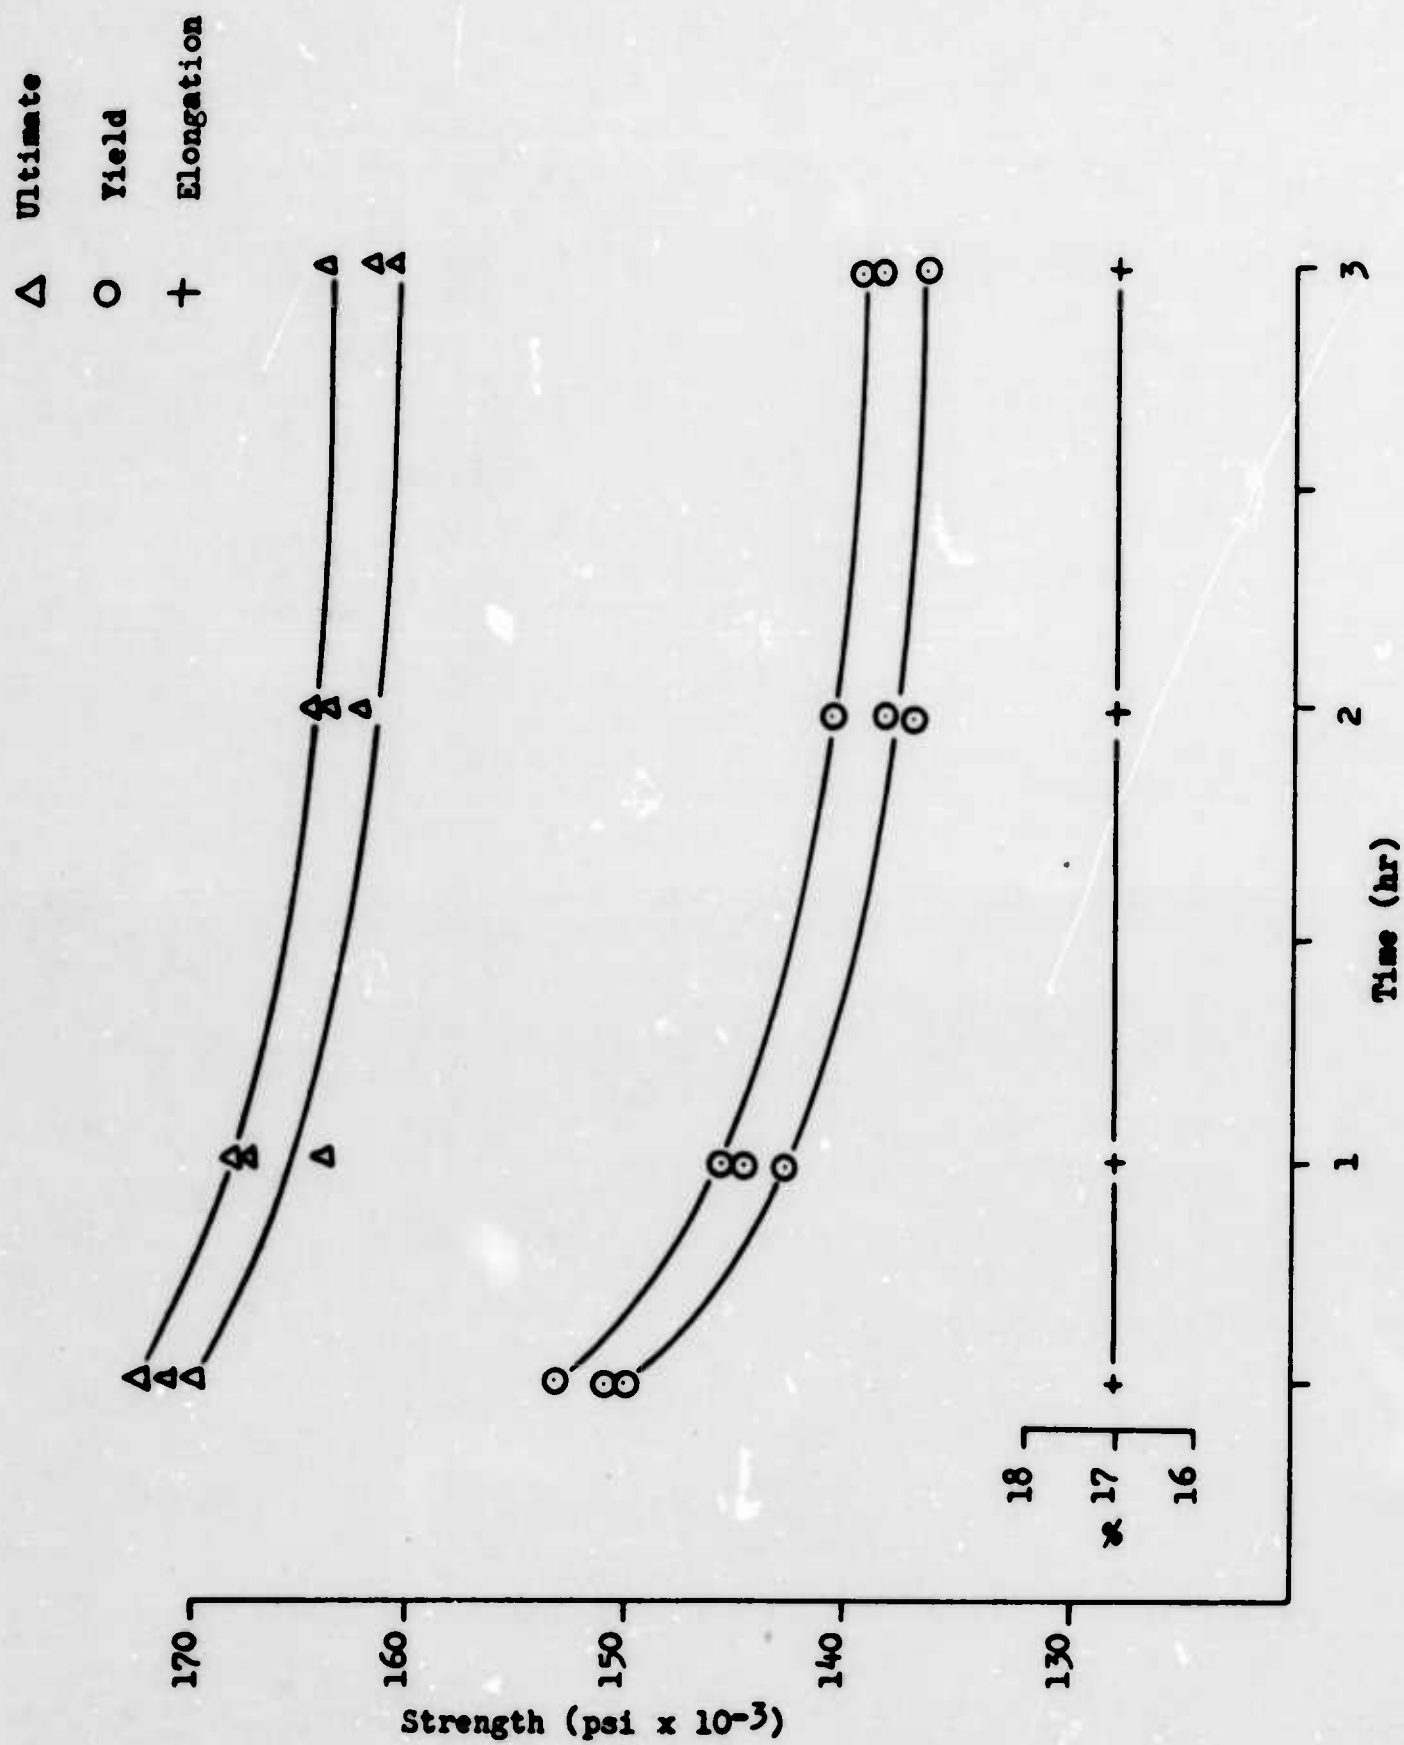
FIGURE 36. Smooth Tensile Properties As A Function of Tempering Time
At 1050°F of AM 350 SCT 1050 Condition

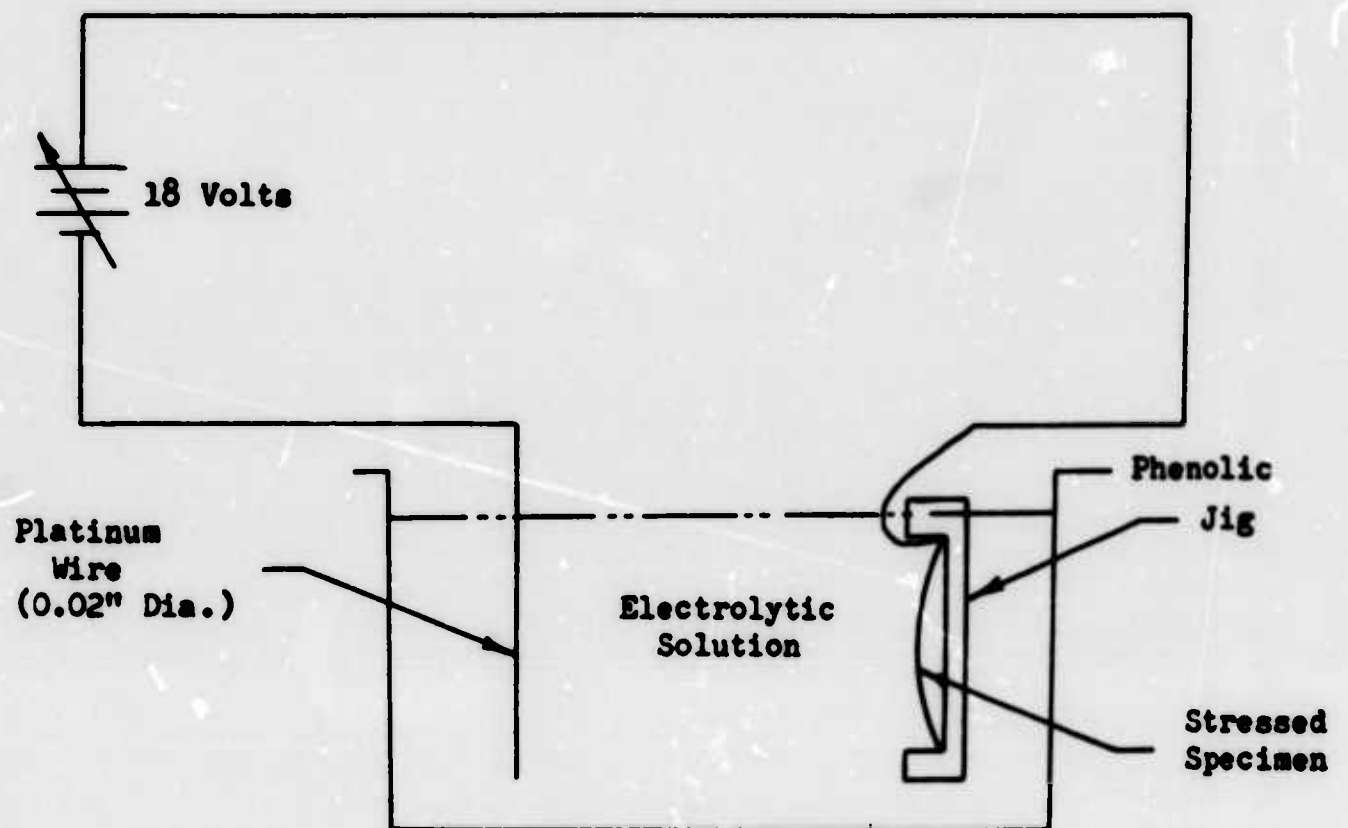
FIGURE 37. Electrolytic Cell Arrangement Used in Hydrogen Embrittlement and Stress Corrosion Crack Shape Studies

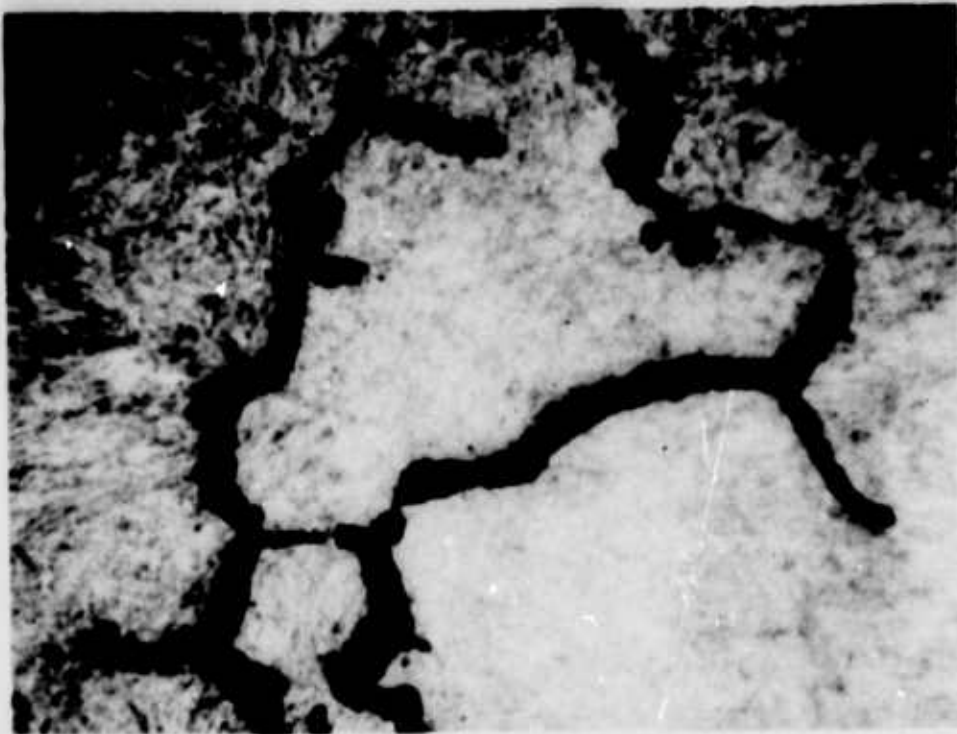
FIGURE 38
Cracking in 4340M Specimen Anodic in 3% NaCl Solution
Nital 1200X

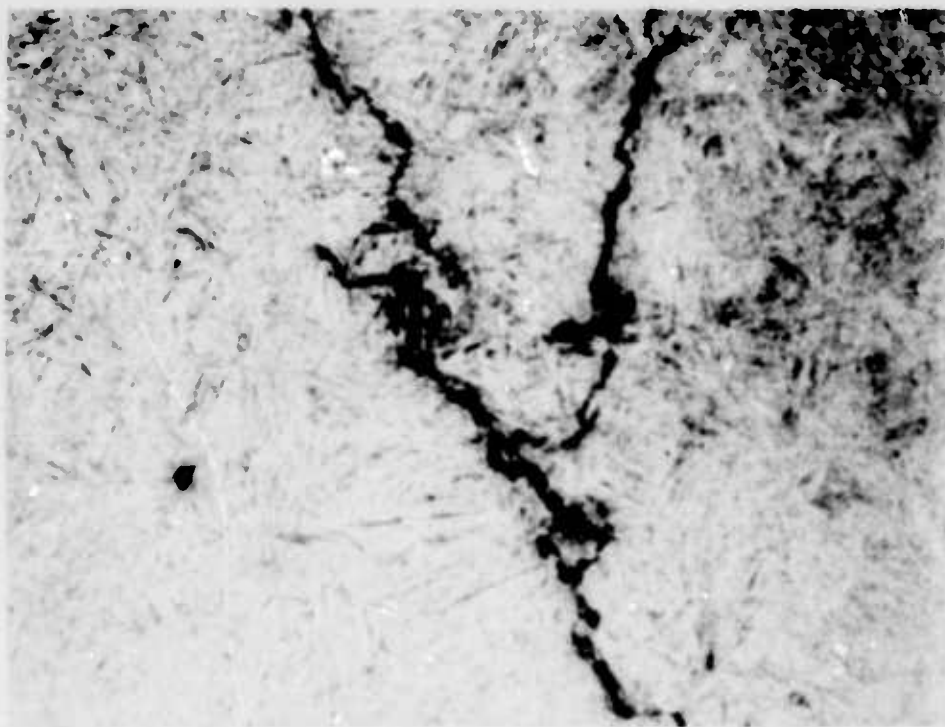
FIGURE 39
Cracking in 4340M Specimen Cathodic in 3% NaCl Solution
Nital 1200X

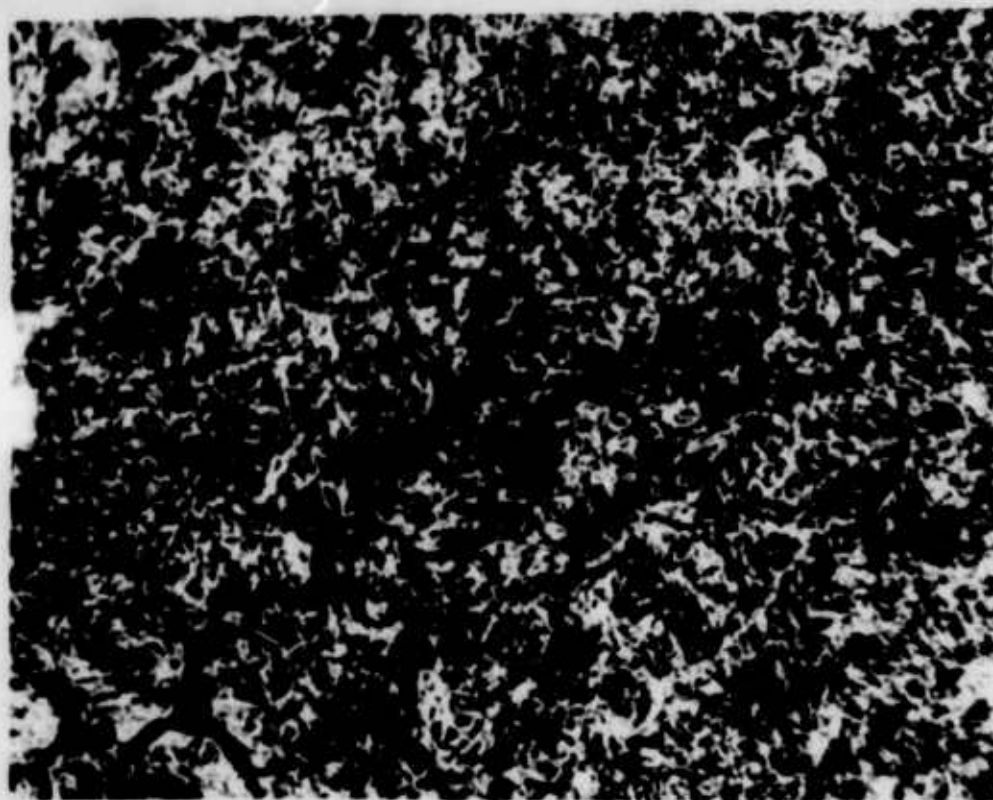
FIGURE 40
Cracking in 4340 Specimen Anodic in 3% NaCl Solution
Cu Cl₂ 500X

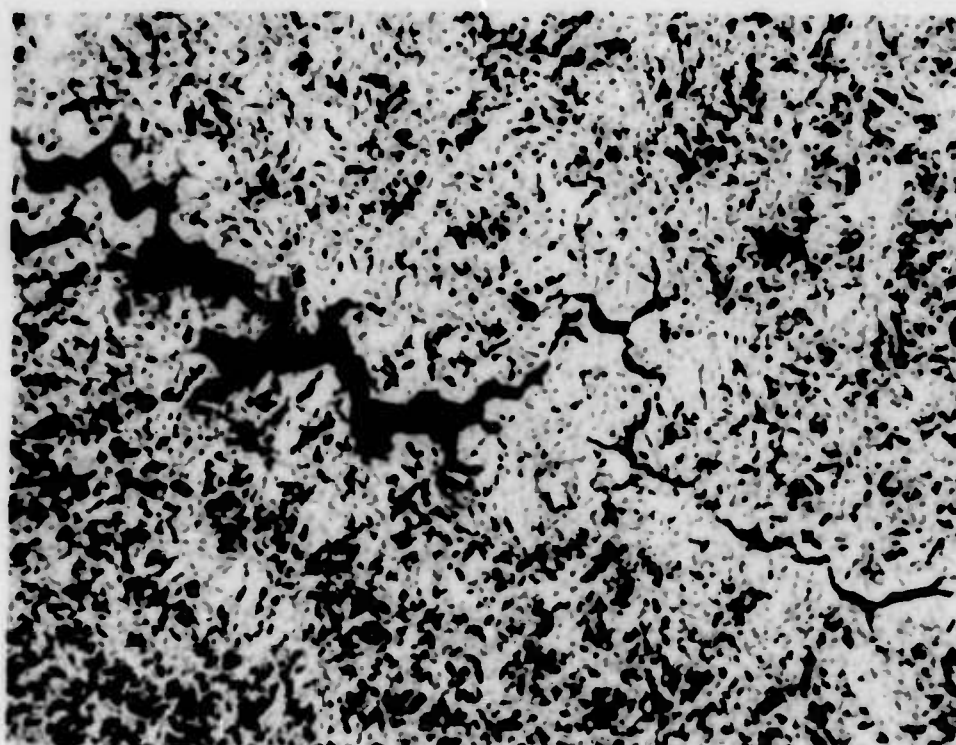
FIGURE 41
Cracking in 4340 Specimen Cathodic in 0.125 N Na₂S Solution
Cu Cl₂ 500X

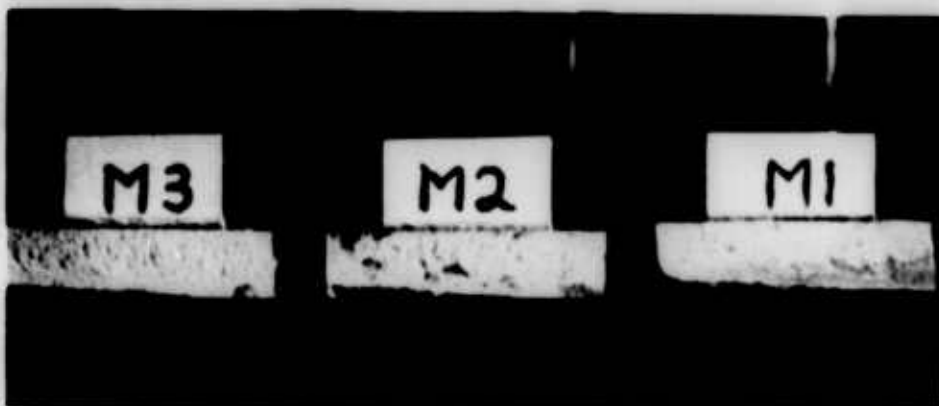
FIGURE 44. Fracture Faces of 4340 (Billet M)
Surface Ground Specimens

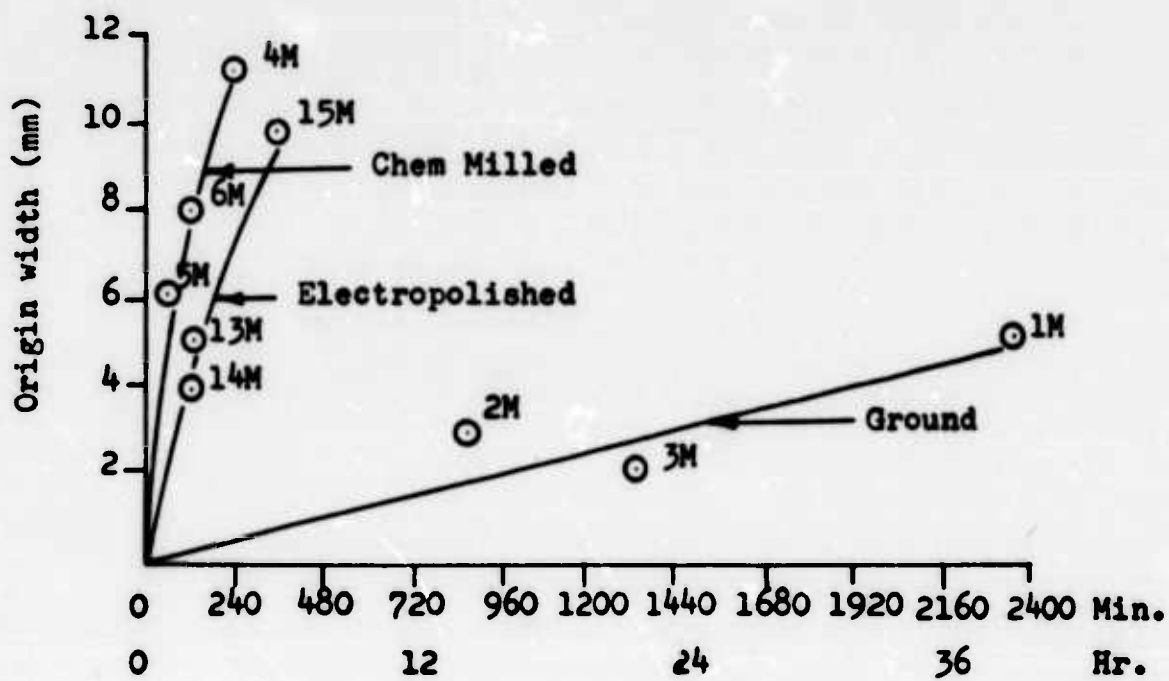
FIGURE 45. Fracture Origin Width Versus Time to Failure
4340 (Billet M)

a 90% Yield Strength
b 75% Yield Strength
c 50% Yield Strength

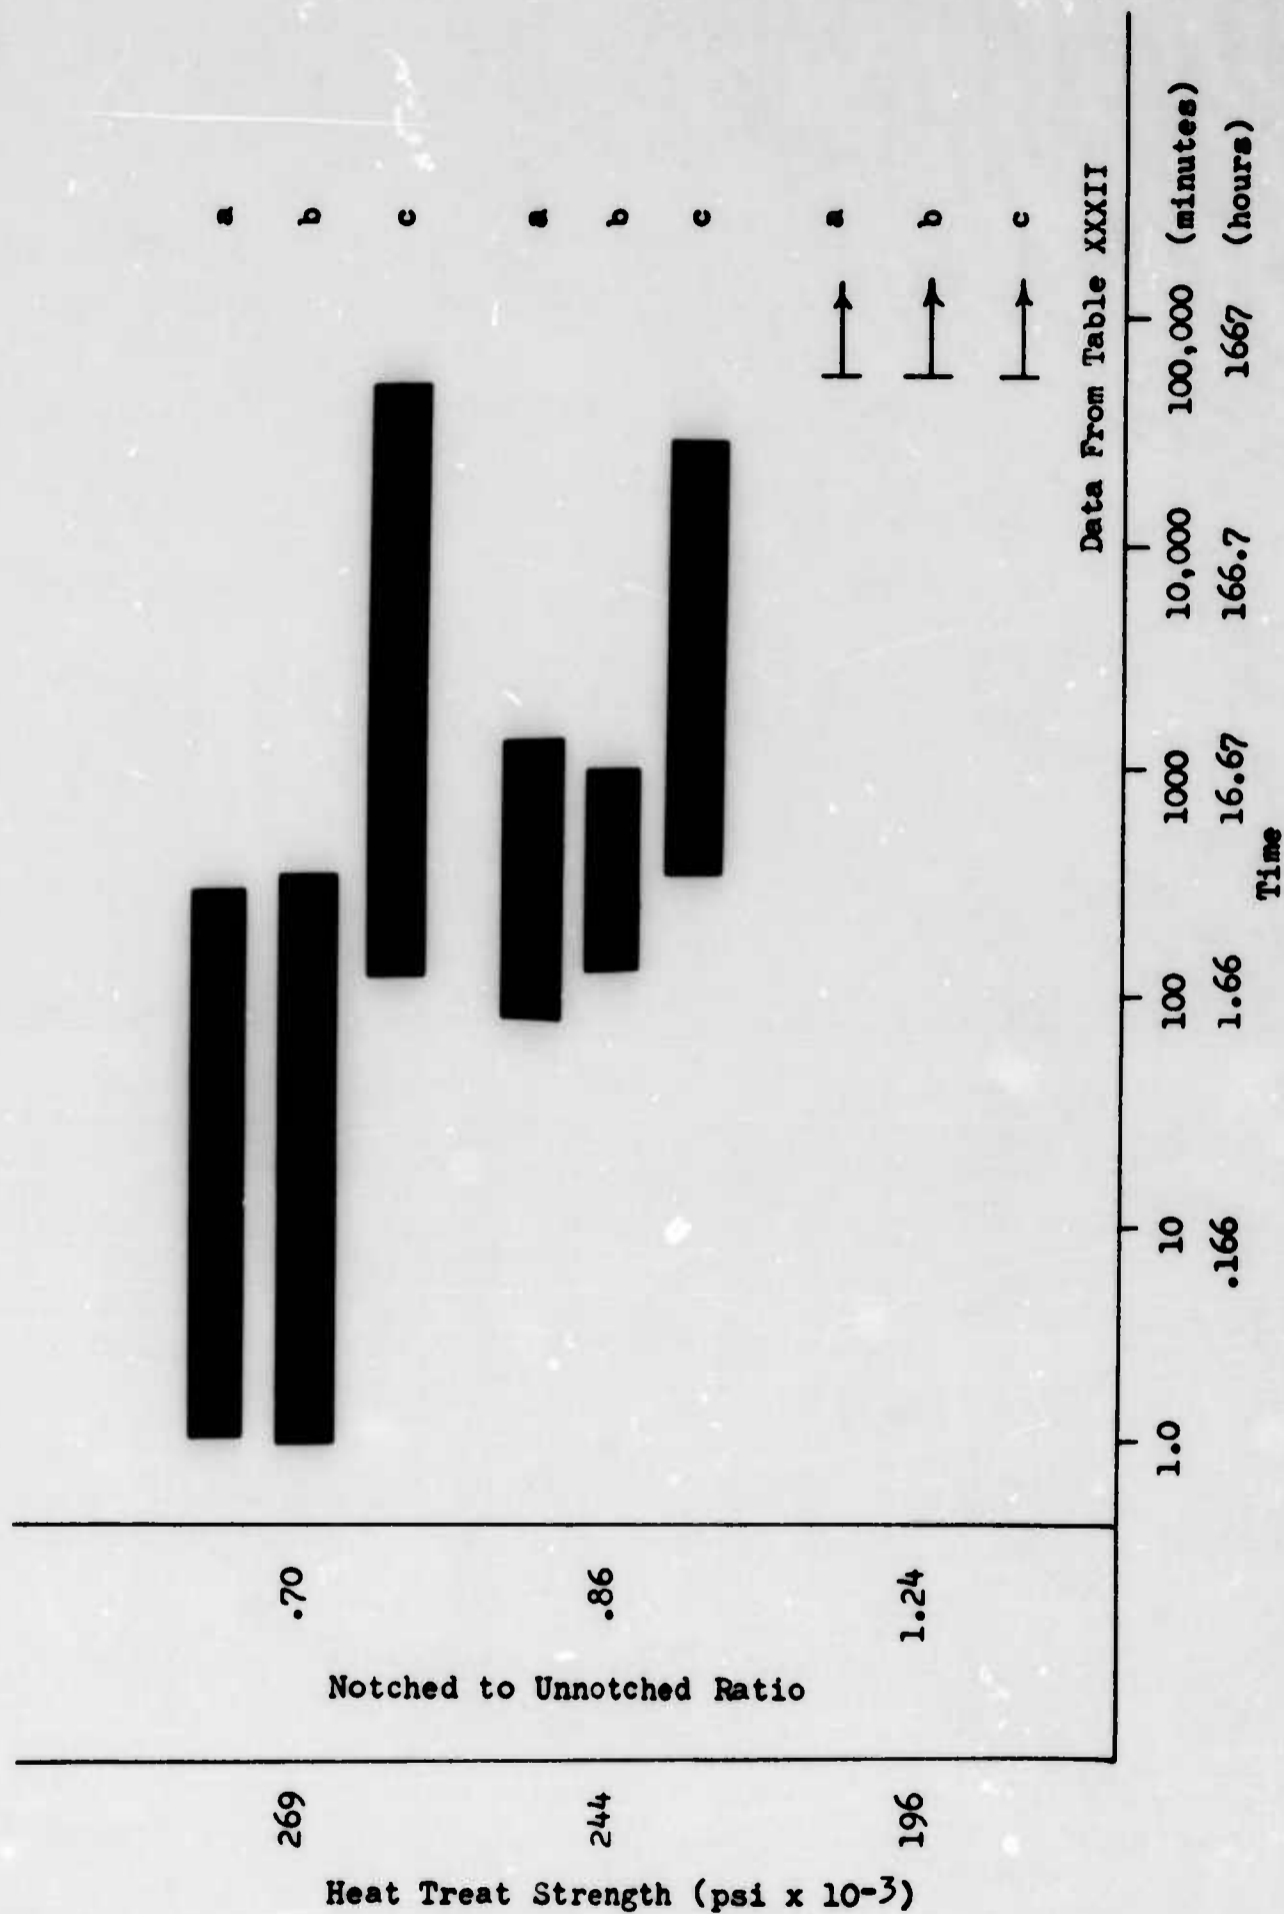
FIGURE 46. Range of Failure Times of Martempered 4340 (Billet N)

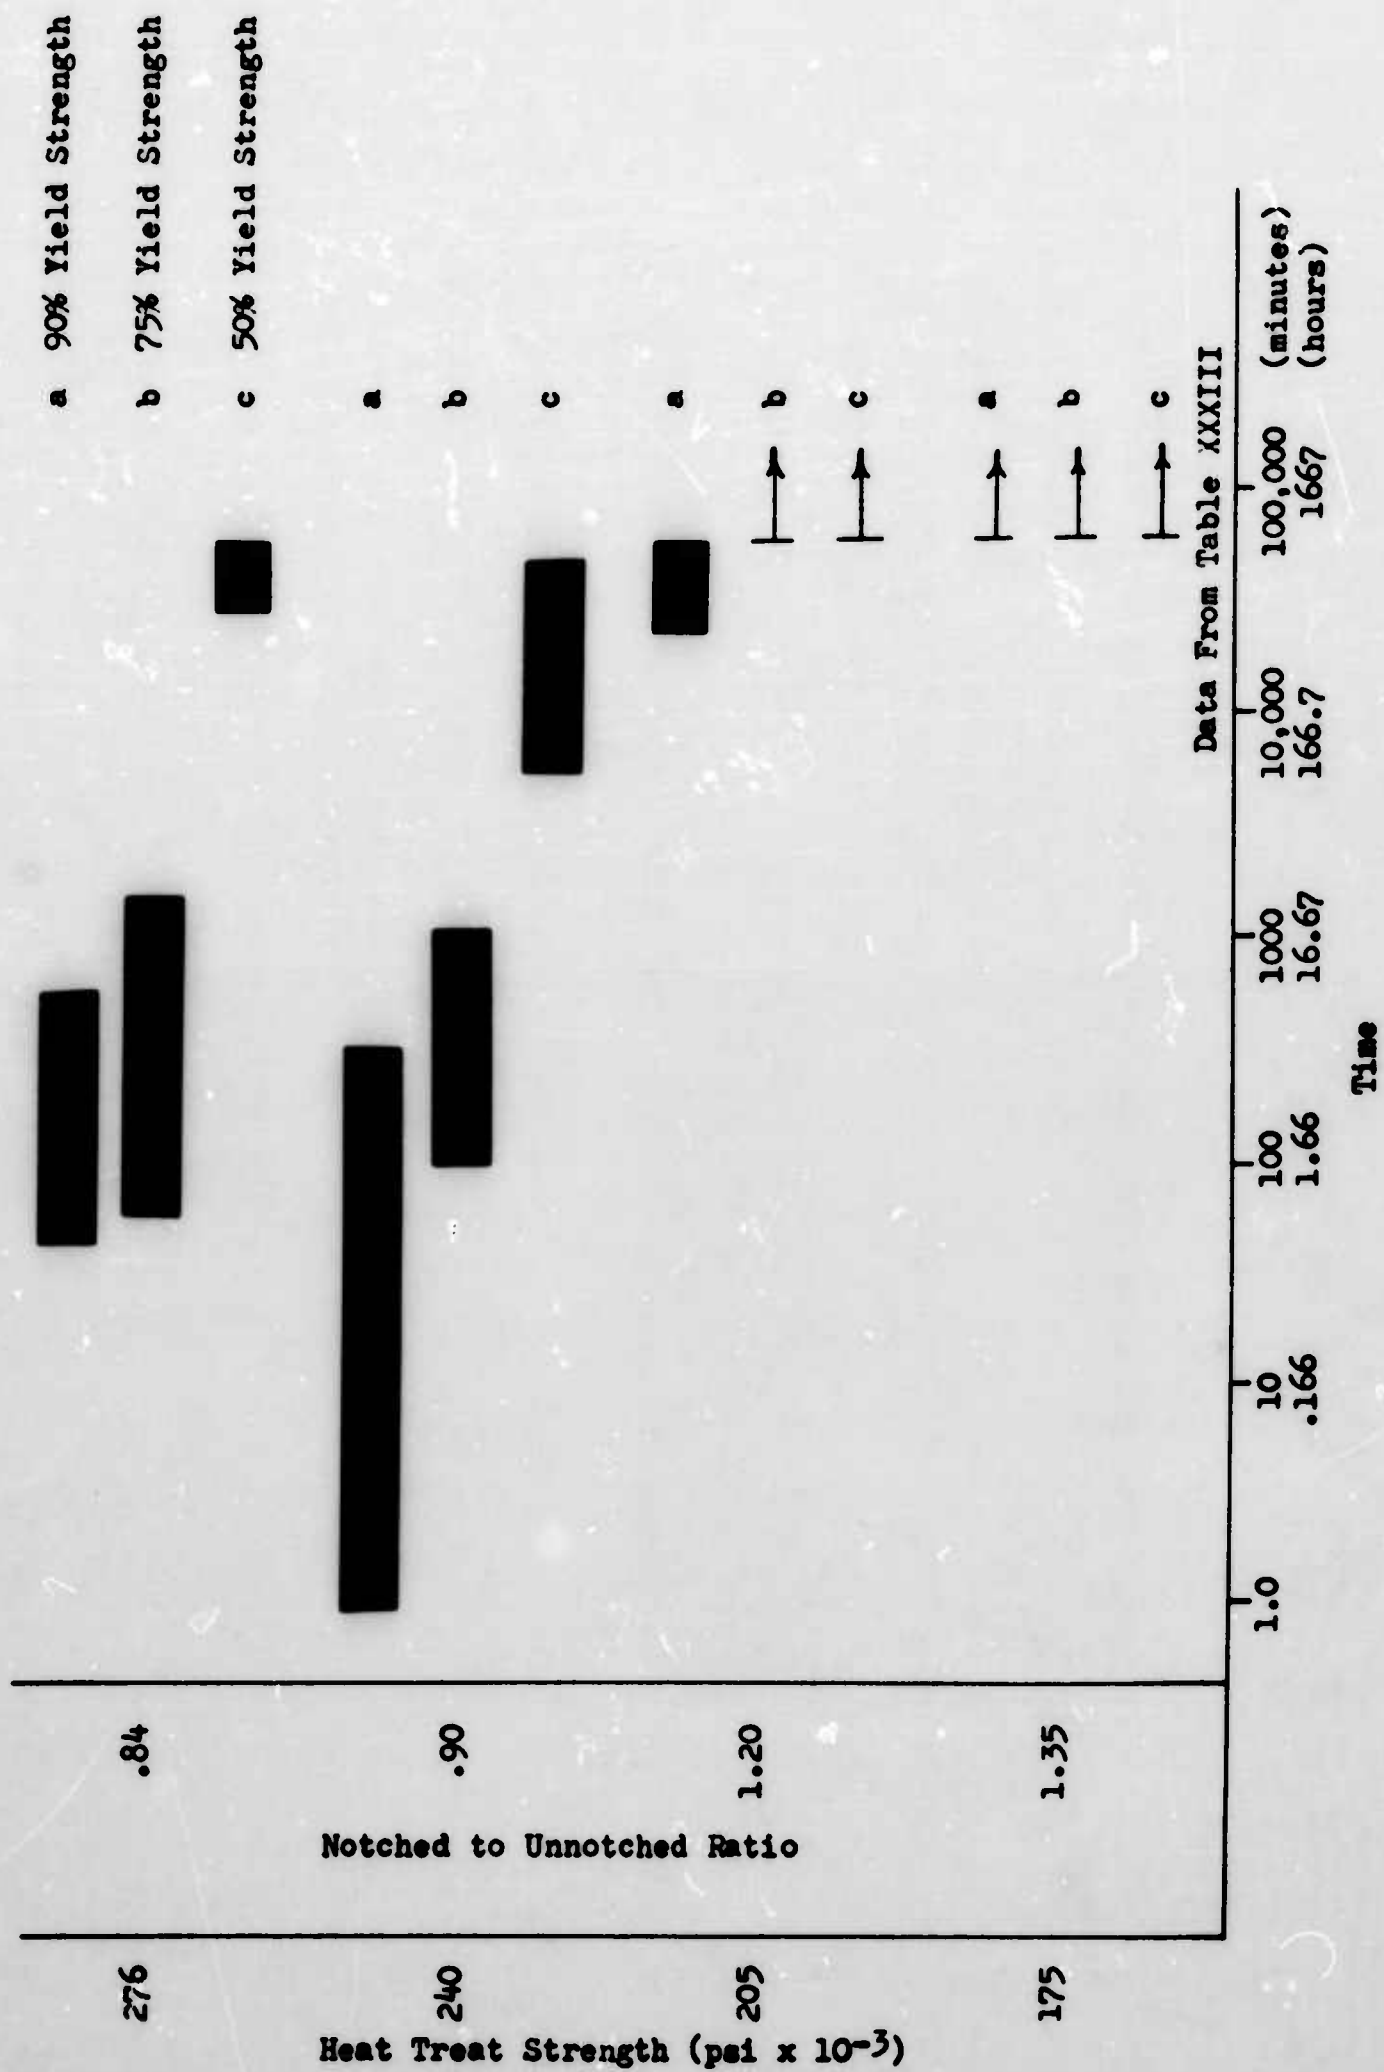
FIGURE 47. Range of Failure Times of 4340 (Billet K)

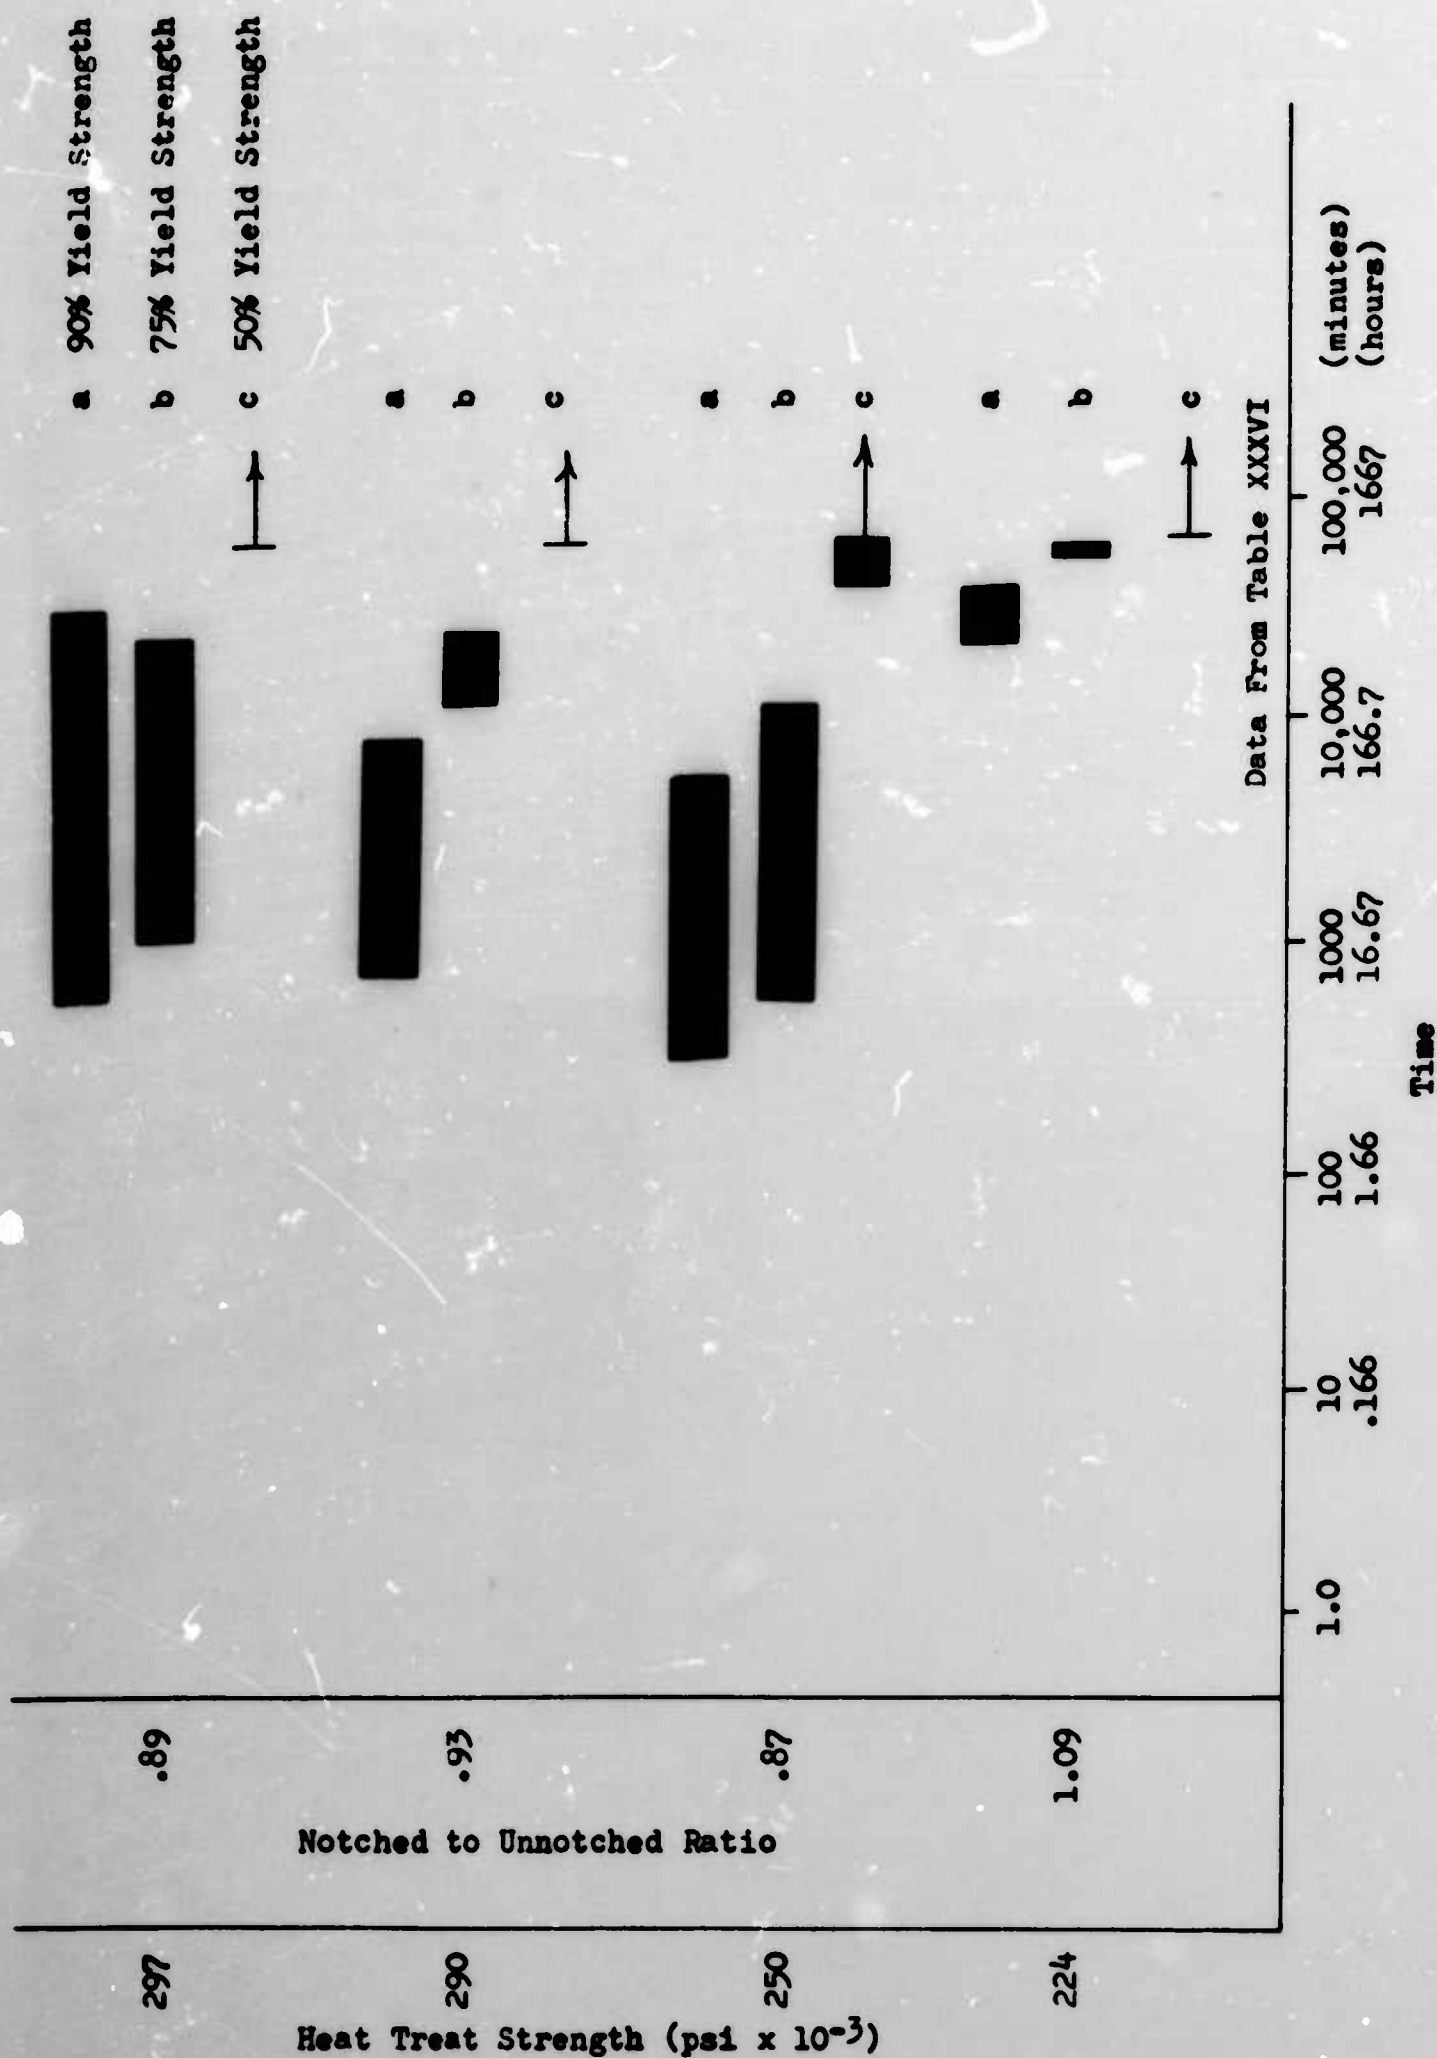
FIGURE 48. Range of Failure Times of 4340M (Billet P)

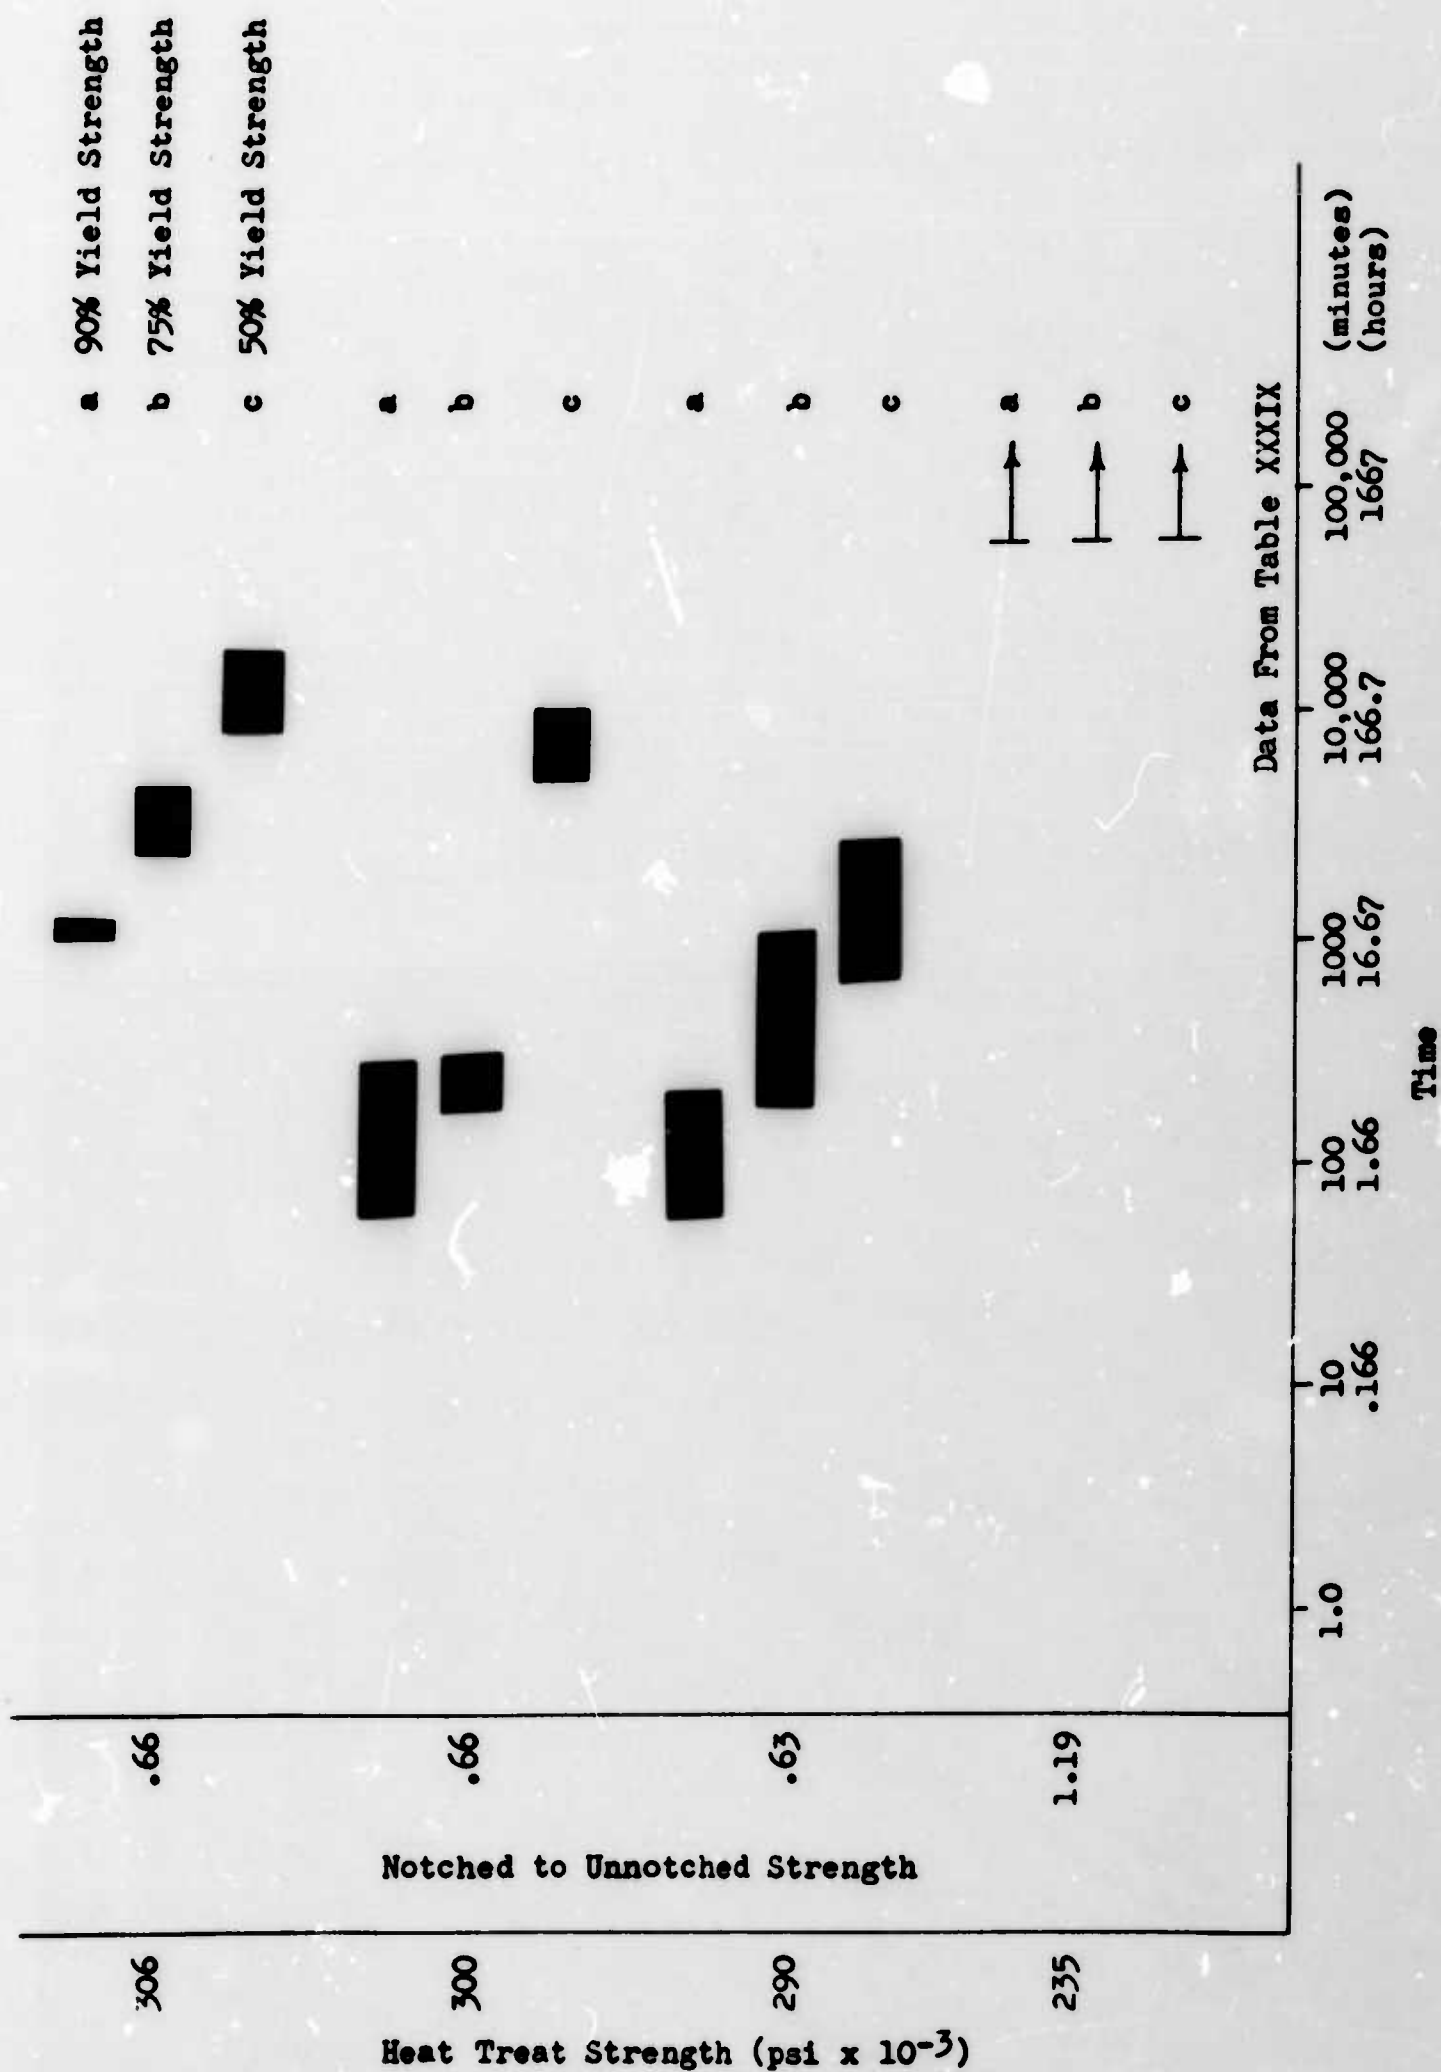
FIGURE 49. Range of Failure Times of H-11 (Billet V)
